**Flood Control Project Maintenance  
Levee Inspections**  
**LMA District Cover Sheet**  
**Spring 2019 Levee Inspection Results**

**Reclamation District No. 1500 Sutter Basin**

**Spring 2019 Levee Inspection Results**

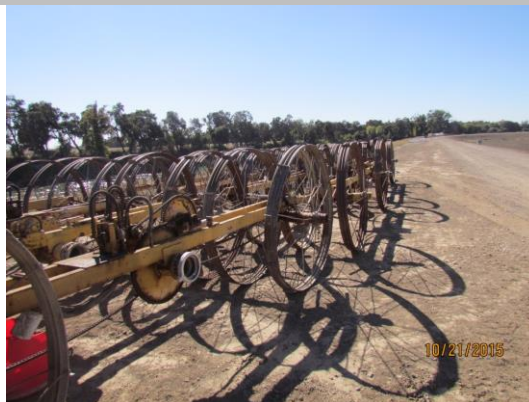
Photo 1 of 1 : SP\_2019\_RD1500\_189\_119\_20190304\_00062.jpg

LM Start	13.78	Rating **	M	Issue No.	119
LM End	13.82	Issue Type +	En	Location *	WS
Category	Earthen Levee			GPS Latitude/Longitude	
				Start	End
Item	Encroachments			38.859679 °	38.859201 °
				-121.780862 °	-121.781276 °
DWR ID	DWR_RD1500_01_f_2015_119				
Comment Code					
EQ : Equipment					
Inspector Comment

View of the equipment on the crown of the levee looking upstream. Fall 2015.

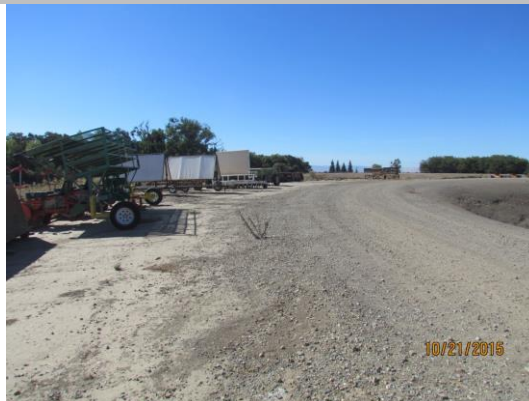
Photo 1 of 1 : SP\_2019\_RD1500\_189\_28\_20190304\_00013.jpg

LM Start	13.96	Rating **	M	Issue No.	28
LM End	13.96	Issue Type +	En	Location *	WS
Category	Earthen Levee			GPS Latitude/Longitude	
				Start	End
Item	Encroachments			38.857625 °	38.857625 °
				-121.782832 °	-121.782832 °
DWR ID	DWR_RD1500_01_s_2012_28				
Comment Code					
EQ : Equipment					
Inspector Comment					
Equipment are on the waterside shoulder but does not obstruct access.

View of the equipment on the crown side of the levee looking upstream. Fall 2015.

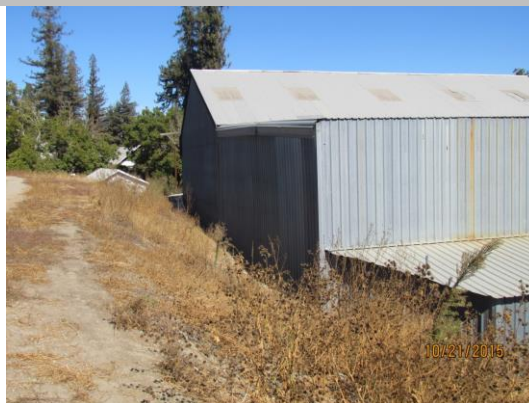
Photo 1 of 1 : SP\_2019\_RD1500\_189\_30\_20190304\_00014.jpg

LM Start	14.19	Rating **	M	Issue No.	30
LM End	14.19	Issue Type +	En	Location *	LS
Category	Earthen Levee			GPS Latitude/Longitude	
				Start	End
Item	Encroachments			38.860624 °	38.860624 °
				-121.783324 °	-121.783324 °
DWR ID	DWR_RD1500_01_s_2012_30				
Comment Code					
BU : Building					
Inspector Comment					
Concrete stemwall into levee embankment.

View of the building on the landward side of the levee looking upstream. Fall 2015.

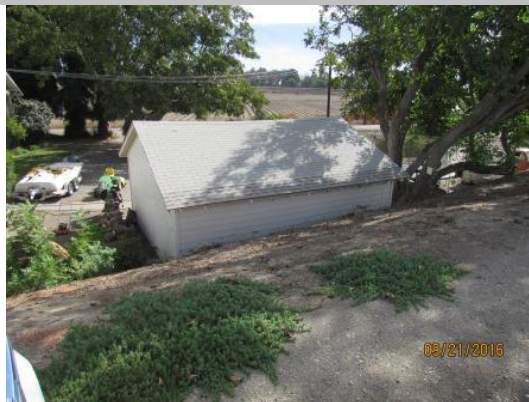
Photo 1 of 1 : SP\_2019\_RD1500\_189\_138\_20190304\_00075.jpg

LM Start	14.21	Rating **	M	Issue No.	138
LM End	14.21	Issue Type +	En	Location *	LS
Category	Earthen Levee			GPS Latitude/Longitude	
				Start	End
Item	Encroachments			38.860951 °	38.860951 °
				-121.783422 °	-121.783422 °
DWR ID	DWR_RD1500_01_f_2016_138				
Comment Code					
BU : Building					
Inspector Comment

View of a building encroaching the levee on landside toe. Fall 2016.

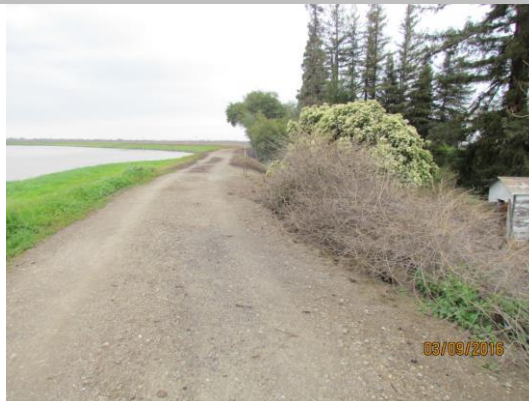
Photo 1 of 1 : SP\_2019\_RD1500\_189\_31\_20190304\_00015.jpg

LM Start	14.24	Rating **	M	Issue No.	31
LM End	14.28	Issue Type +	En	Location *	LS
Category	Earthen Levee			GPS Latitude/Longitude	
				Start	End
Item	Vegetation			38.861335 °	38.861913 °
				-121.783605 °	-121.783751 °
DWR ID	DWR_RD1500_01_s_2012_31				
Comment Code					
V6 : Landscaping					
Inspector Comment

View of the landscaping on the landward side of the levee looking upstream. Spring 2016.

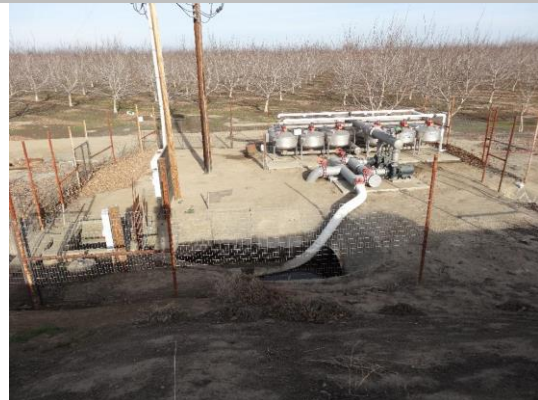
Photo 3 of 3 : UCIP\_SP\_2019\_28486\_52459.jpg

LS view: concrete distribution box on levee toe. Water filtration plant off the levee toe.

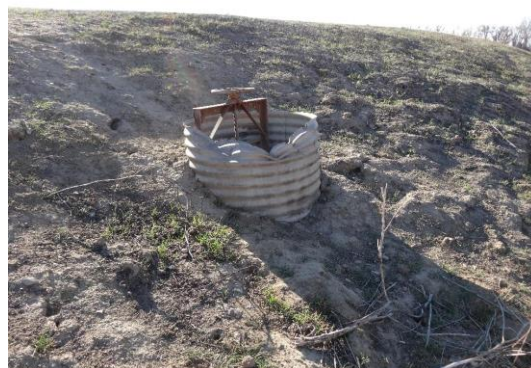
Photo 1 of 3 : UCIP\_SP\_2019\_28489\_52479.jpg

Comment Code					
Inspector Comment					
FS_ID:28489 DS_ID:20081 EP_NO: 8510 Repair Type: Non-Urgent Crossing Status: Found UCIP Comments: Pipe not visible on river bank.Cleaning and clearing require around slide gates. May be abandoned. FIELD_STRUCT_DESC: 24-inch corrugated metal irrigation discharge pipe through the levee, 15 feet below the crown. Slide gate in a 36-inch corrugated metal pipe (CMP) riser on the waterside (WS) slope. Slide gate on a concrete U-shaped headwall and irrigation ditch at the landside (LS) toe. (24-inch corrugated metal irrigation discharge pipe through the levee retained under Permit No. 8510, 1972 - John Clauss Jr. et al.). [Additional Reference(s): DWR Levee Log, 1990. USACE Sacramento O&M Manual 128, March 1960, (HLM 17.14)]. FS Date: 1/14/2014

WS view: CMP riser with slide gate on levee slope.

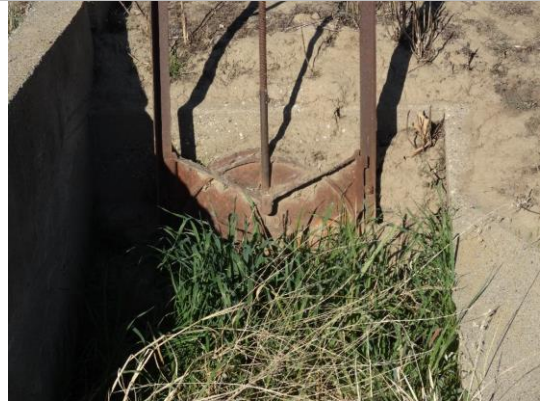
Photo 3 of 3 : UCIP\_SP\_2019\_28489\_52477.jpg

Item	DWR UCIP Field Study			38.885098 °	38.885098 °	
				-121.812884 °	-121.812884 °	
DWR ID	20081					
Comment Code						
Inspector Comment						
FS_ID:28489						
DS_ID:20081						
EP_NO: 8510						
Repair Type: Non-Urgent						
Crossing Status: Found						
UCIP Comments: Pipe not visible on river bank.Cleaning and clearing require around slide gates. May be abandoned.						
FIELD_STRUCT_DESC: 24-inch corrugated metal irrigation discharge pipe through the levee, 15 feet below the crown. Slide gate in a 36-inch corrugated metal pipe (CMP) riser on the waterside (WS) slope. Slide gate on a concrete U-shaped headwall and irrigation ditch at the landside (LS) toe. (24-inch corrugated metal irrigation discharge pipe through the levee retained under Permit No. 8510, 1972 - John Clauss Jr. et al.). [Additional Reference(s): DWR Levee Log, 1990. USACE Sacramento O&M Manual 128, March 1960, (HLM 17.14)].

LS view: U type concrete headwall with slide gate on levee toe.

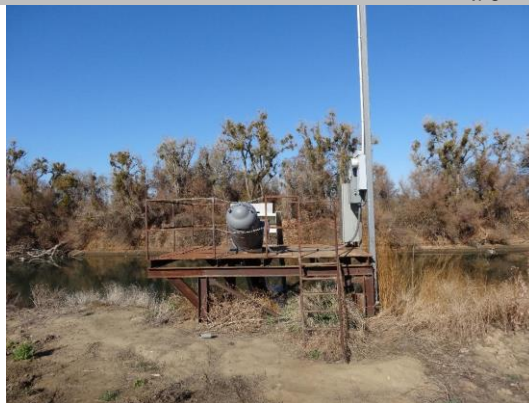
Photo 1 of 3 : UCIP\_SP\_2019\_28490\_52485.jpg

Comment Code						
Inspector Comment						
FS_ID:28490 DS_ID:20066 EP_NO: 1739 Repair Type: Non-Urgent Crossing Status: Found UCIP Comments: Most of the pipe exposed on levee slope.Pipe leakage repaired recently.Siphon breaker requires protection. FIELD_STRUCT_DESC: 20-inch welded steel irrigation discharge pipe through the levee, 5.5 feet below the crown. Slant pump mounted on a steel structure on the waterside (WS). Siphon breaker on the landside (LS) slope. Pipe discharges into a 6-foot by 5.5-foot, outside dimensions, concrete distribution box and irrigation ditch at the LS toe. Fish screen added in 2011. (Installation of a slant pump and a discharge pipe through the levee authorized under Permit No. 1739, 1953 - John Clauss. Installation of a fish screen authorized under Permit No. 18678, [permit missing], [RM 102.50]). [Additional Reference(s): DWR Levee Log, 2005. USACE Sacramento O&M Manual 128, March 1960, (HLM 17.45)]. FS Date: 1/14/2014

WS view: slant pump on steel platform on levee berm.

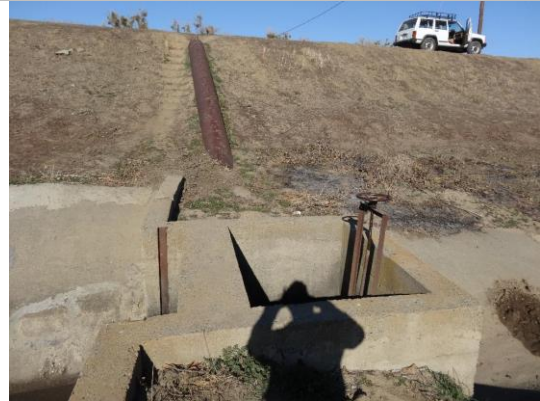
Photo 3 of 3 : UCIP\_SP\_2019\_28490\_52483.jpg

Comment Code					
Inspector Comment					
FS_ID:28490 DS_ID:20066 EP_NO: 1739 Repair Type: Non-Urgent Crossing Status: Found UCIP Comments: Most of the pipe exposed on levee slope.Pipe leakage repaired recently.Siphon breaker requires protection. FIELD_STRUCT_DESC: 20-inch welded steel irrigation discharge pipe through the levee, 5.5 feet below the crown. Slant pump mounted on a steel structure on the waterside (WS). Siphon breaker on the landside (LS) slope. Pipe discharges into a 6-foot by 5.5-foot, outside dimensions, concrete distribution box and irrigation ditch at the LS toe. Fish screen added in 2011. (Installation of a slant pump and a discharge pipe through the levee authorized under Permit No. 1739, 1953 - John Clauss. Installation of a fish screen authorized under Permit No. 18678, [permit missing], [RM 102.50]). [Additional Reference(s): DWR Levee Log, 2005. USACE Sacramento O&M Manual 128, March 1960, (HLM 17.45)]. FS Date: 1/14/2014

LS view: exposed pipe on levee slope, and concrete distribution box on levee toe.

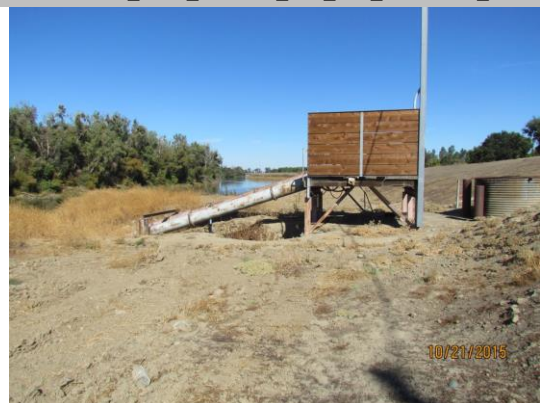
Photo 1 of 3 : SP\_2019\_RD1500\_189\_121\_20190304\_00064.jpg

LM Start	17.34	Rating **	M	Issue No.	121
LM End	17.34	Issue Type +	En	Location *	WS
Category	Earthen Levee			GPS Latitude/Longitude	
				Start	End
Item	Encroachments			38.888137 °	38.888137 °
				-121.807273 °	-121.807273 °
DWR ID	DWR_RD1500_01_f_2015_121				
Comment Code					
PI : Pipe					
Inspector Comment					
Pipe is causing the erosion on the berm of the levee.

Perspective view of the pump on the waterward side of the levee looking upstream. Fall 2015.

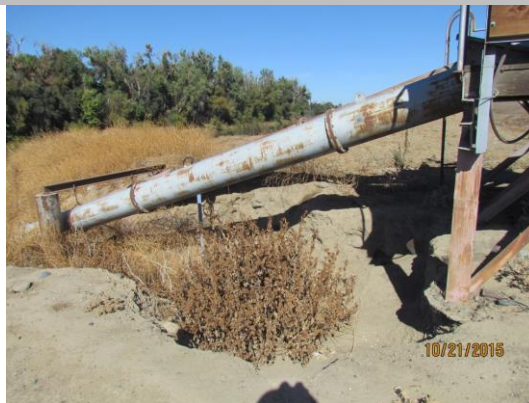
Photo 2 of 3 : SP\_2019\_RD1500\_189\_121\_20190304\_00065.jpg

LM Start	17.34	Rating **	M	Issue No.	121 (cont)	
LM End	17.34	Issue Type +	En	Location *	WS	
Category	Earthen Levee			GPS Latitude/Longitude		
				Start	End	
Item	Encroachments			38.888137 °	38.888137 °	
				-121.807273 °	-121.807273 °	
DWR ID	DWR_RD1500_01_f_2015_121					
Comment Code						
PI : Pipe						
Inspector Comment						
Pipe is causing the erosion on the berm of the levee.

There is erosion underneath the pipe on the waterward berm area. Fall 2015.

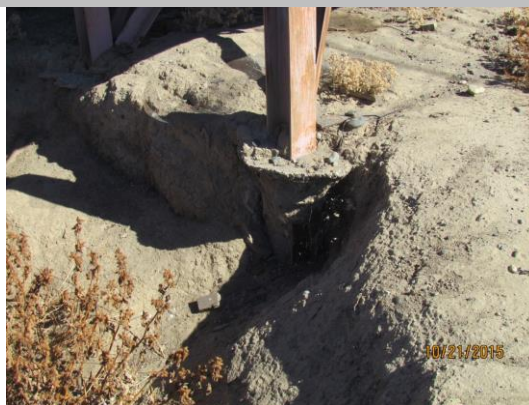
Photo 3 of 3 : SP\_2019\_RD1500\_189\_121\_20190304\_00066.jpg

The concrete for the base stand has been exposed due to erosion.

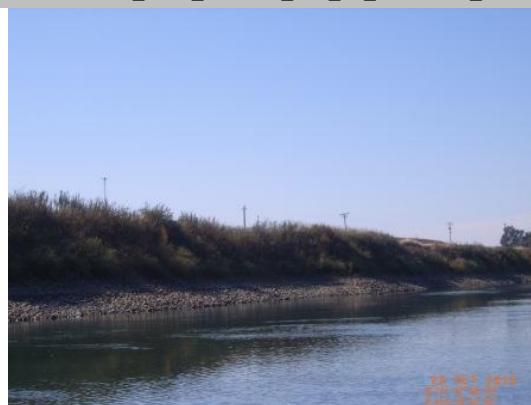
Photo 1 of 1 : SP\_2019\_RD1500\_189\_80\_20190304\_00031.jpg

LM Start	18.38	Rating **	A/W	Issue No.	80
LM End	19.06	Issue Type +	Ma	Location *	WS
Category	Supplemental			GPS Latitude/Longitude	
				Start	End
Item	2017 USACE Erosion Survey, DRAFT			38.901337 °	38.902721 °
				-121.801175 °	-121.790677 °
DWR ID	DWR_RD1500_01_f_2018_80				
Comment Code					
Inspector Comment					
2017 Site ID: SAC 104.0 L					
Status: Eroding					
2017 Field Notes: Bank slope is relatively stable.					
Site History: 1997 - Pocket failures of cobble revetment toe; scallops of rock loss along the bank; irregular bankline developing. 2001 - Small scallops in the toe of the berm. 2005 - Still multiple erosion pockets in the toe. 2006 - Two new small slumps. 2011 - Old cobble continue to fail causing minor slumping. 2012 - Portions of site appears to be stabilizing. 2016- Cobble revetment continues to fail.

USACE 2013 Photo #1

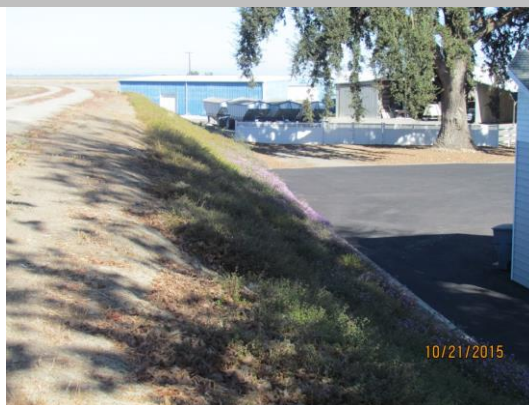
Photo 2 of 2 : SP\_2019\_RD1500\_189\_37\_20190304\_00019.jpg

View of the groundcover on the landward side of the levee looking upstream. Fall 2015.

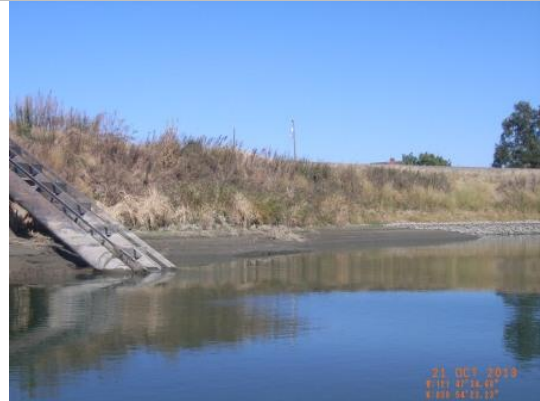
Photo 1 of 1 : SP\_2019\_RD1500\_189\_81\_20190304\_00032.jpg

LM Start	19.16	Rating **	A/W	Issue No.	81
LM End	19.47	Issue Type +	Ma	Location *	WS
Category	Supplemental			GPS Latitude/Longitude	
				Start	End
Item	2017 USACE Erosion Survey, DRAFT			38.904041 °	38.906697 °
				-121.790298 °	-121.792796 °
DWR ID	DWR_RD1500_01_f_2018_81				
Comment Code					
Inspector Comment					
2017 Site ID: SAC 104.5 L					
Status: Eroding					
2017 Field Notes: Site appears stable.					
Site History: 1997 - Cobbles eroded off the clay materials; not much evidence of erosion on the toe; cobble loss on the toe. 2011 - Some minor new erosion.

USACE 2013 Photo #1

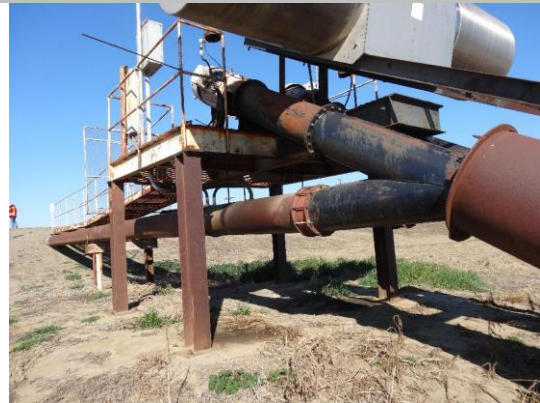
Photo 1 of 3 : UCIP\_SP\_2019\_28524\_52551.jpg

Comment Code						
Inspector Comment						
FS_ID:28524 DS_ID:20004 EP_NO: 15681 Repair Type: Non-Urgent Crossing Status: Found UCIP Comments: Obstructed siphon breakers on landside.Two 3-inch conduit through the levee.Service box on pump platform.Pumping plant was working during the field visit. FIELD_STRUCT_DESC: 1 of 2: 16-inch steel irrigation discharge pipe, asphalt coated inside and out and wrapped with asphalt saturated felt, through the levee, 1.5 feet below the crown. Cutoff wall at the centerline of the levee. Two slant pumps supported by a steel piling structure on the riverbank. Steel walkway to the pump platform. Siphon breakers in steel pipe risers on the landside (LS) shoulder. Pipe discharges into a concrete discharge box off the LS toe. (Installation of a discharge pipe through the levee and a slant pump on the riverbank authorized under Permit No. 15681, 1991 - Blackfraires Investment). FS Date: 1/14/2014

WS view: pipe, walkway, slant pump, and steel platform on levee berm.

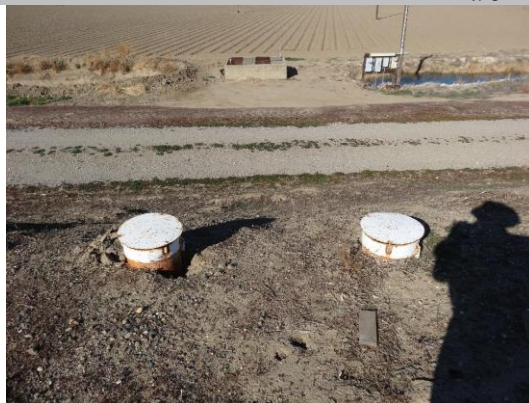
Photo 2 of 3 : UCIP\_SP\_2019\_28524\_52550.jpg

LS view: siphon breakers in steel pipe risers (bottom) on levee slope and concrete distribution (top) box on levee toe.

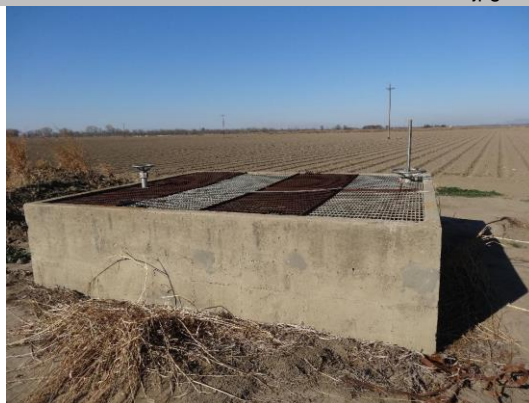
Photo 3 of 3 : UCIP\_SP\_2019\_28524\_52549.jpg

LS view: concrete distribution box on levee toe.

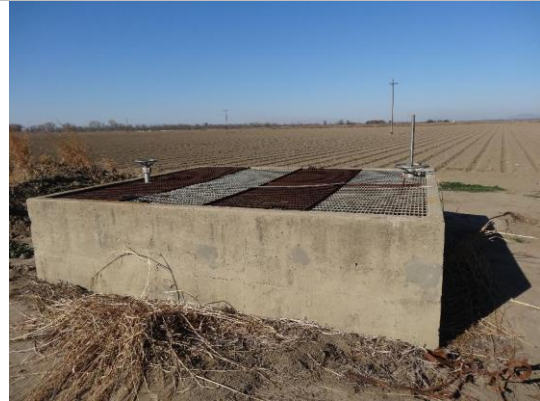
Photo 3 of 3 : UCIP\_SP\_2019\_28927\_53214.jpg

LS view: concrete distribution box on levee toe.

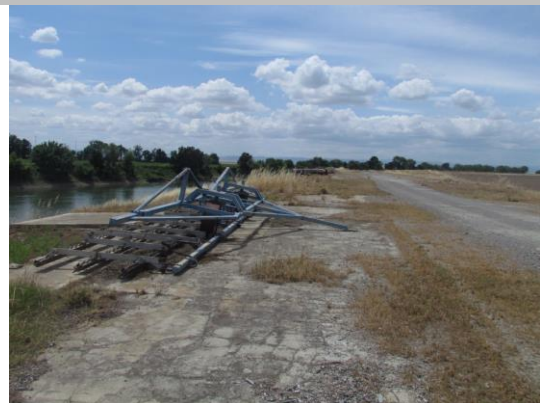
Photo 1 of 1 : SP\_2019\_RD1500\_189\_2549\_20190304\_00087.jpg

LM Start	19.56	Rating **	M	Issue No.	2549
LM End	19.56	Issue Type +	En	Location *	WS
Category	Earthen Levee			GPS Latitude/Longitude	
				Start	End
Item	Encroachments			38.906565 °	38.906565 °
				-121.794472 °	-121.794472 °
DWR ID	DWR_RD1500_01_s_2015_2549				
Comment Code					
EQ : Equipment					
Inspector Comment

View of the equipment on the waterward side of the levee looking upstream. Spring 2015.

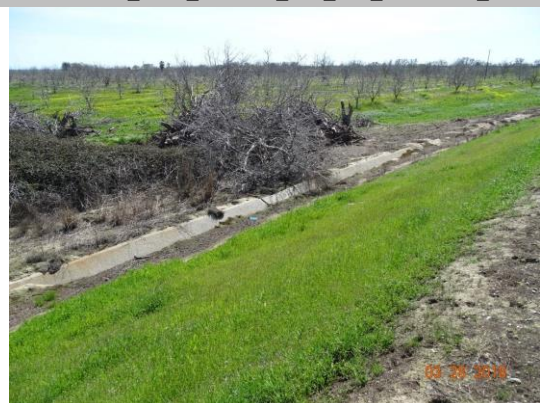
Photo 1 of 1 : SP\_2019\_RD1500\_189\_123\_20190304\_00067.jpg

LM Start	20.97	Rating **	M	Issue No.	123
LM End	21.15	Issue Type +	En	Location *	LS
Category	Earthen Levee			GPS Latitude/Longitude	
				Start	End
Item	Encroachments			38.910885 °	38.913199 °
				-121.804603 °	-121.803256 °
DWR ID	DWR_RD1500_01_s_2018_123				
Comment Code					
DT : Ditch					
Inspector Comment

View of ditch at the landside toe. Spring 2018.

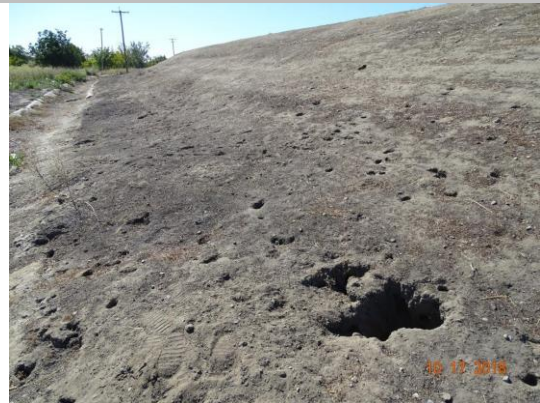
Photo 1 of 1 : SP\_2019\_RD1500\_189\_103\_20190304\_00050.jpg

LM Start	21.10	Rating **	M	Issue No.	103
LM End	21.10	Issue Type +	Ma	Location *	LS
Category	Earthen Levee			GPS Latitude/Longitude	
				Start	End
Item	Animal Control			38.912511 °	38.912511 °
				-121.803355 °	-121.803355 °
DWR ID	DWR_RD1500_01_s_2019_103				
Comment Code					
A3 : No rodents visible, but rodent burrows visible; need to backfill and compact or grout burrows.					
Inspector Comment					
Rodent holes are at the landside toe.

View of rodent holes on the landside slope. Fall 2018.

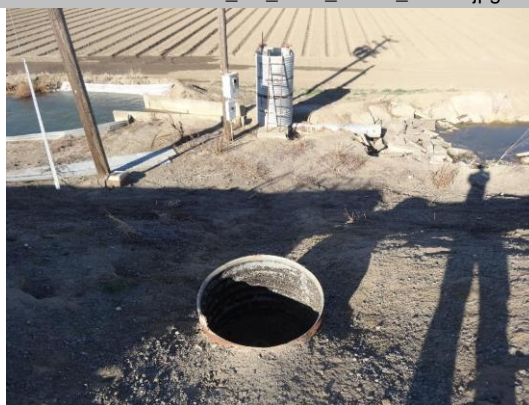
Photo 3 of 3 : UCIP\_SP\_2019\_28528\_52574.jpg

LS view: siphon breaker in CMP riser on levee slope (bottom) and CMP stand pipe (top) on levee toe.

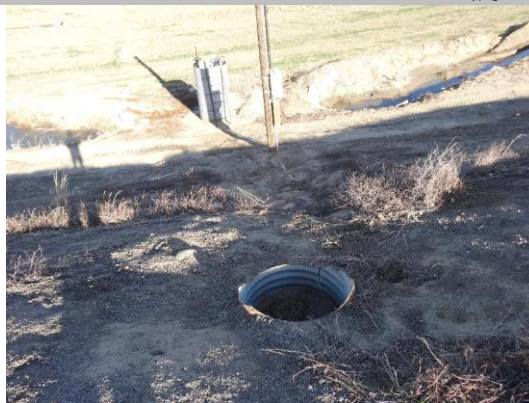
Photo 3 of 3 : UCIP\_SP\_2019\_28583\_52625.jpg

LS view: siphon breaker in CMP riser on levee slope (bottom) and CMP stand pipe (top) on levee toe.

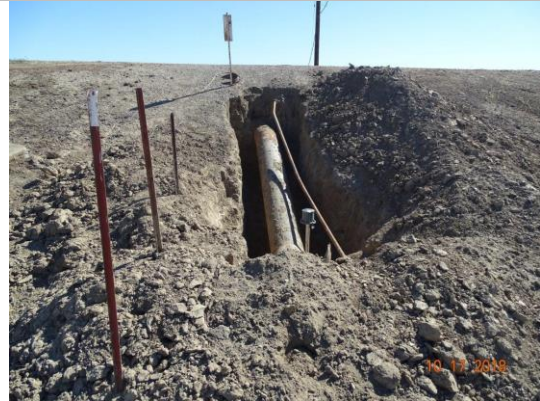
Photo 1 of 3 : UCIP\_SP\_2019\_53023\_78166.jpg

Comment Code					
Inspector Comment					
FS_ID:53023 DS_ID:20072 EP_NO: 2895 Repair Type: Urgent Crossing Status: Found UCIP Comments: 10/18/2018 WS levee slope was disturbed to perform pipe maintenance. Unable to locate a permit for this work. Crossing remains "Urgent" due to soil disturbance on WS levee slope. (O.Yakimov - DWR)Most of the pipe exposed on levee slopes.Leaky pump. Obstructed siphon breaker.Not found- Concrete headwall at landward toe. FIELD_STRUCT_DESC: [Pumping Plant No. 1] 14-inch steel irrigation discharge pipe through the levee, 6.5 feet below the crown. Corrugated metal cutoff wall. 1.5-inch conduit through the levee, 4 feet below the crown. Slant pump and control panel on steel structure on the berm. Siphon breaker in a 24-inch corrugated metal pipe (CMP) riser on the landside (LS) shoulder. 36-inch concrete standpipe at the LS toe. Concrete headwall at the LS toe. Meter pole at the LS toe. (Installation of three centrifugal pumps authorized under Permit No. 2895, 1958 - George Van Ruiten). [Additional Reference(s): DWR Levee Log, 2005. USACE Sacramento O&M Manual 128, March 1960, (HLM 23.92), 24-inch pipe referenced]. FS Date: 10/18/2018 8:01:23 AM

WS levee slope was excavated to do pipe maintenance, photo courtesy of Zach Jojola.

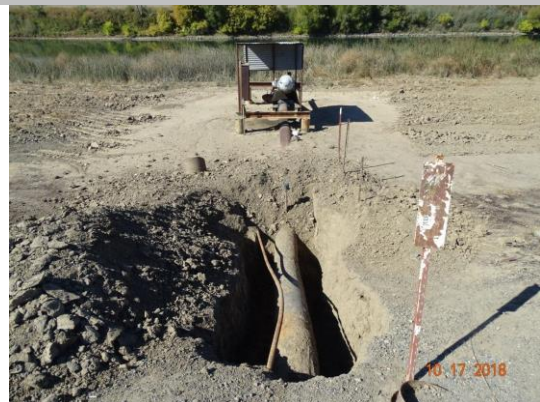
Photo 2 of 3 : UCIP\_SP\_2019\_53023\_78167.jpg

Levee crown view: WS levee slope was excavated to do pipe maintenance, photo courtesy of Zach Jojola.

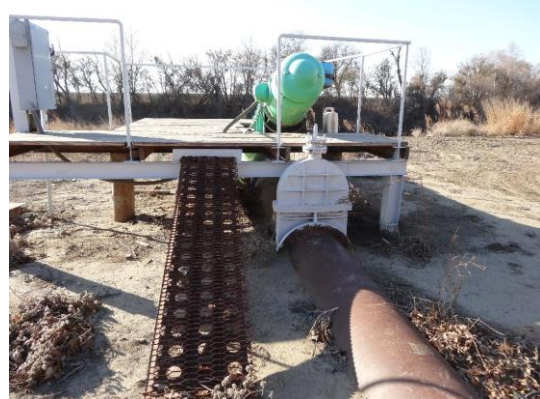
Photo 1 of 3 : UCIP\_SP\_2019\_28603\_52667.jpg

Comment Code						
Inspector Comment						
FS_ID:28603 DS_ID:24757 EP_NO: 10057 Repair Type: Non-Urgent Crossing Status: Found UCIP Comments: Plant was working during field visit.Leaky pipe near pump. FIELD_STRUCT_DESC: 24-inch steel irrigation discharge pipe through the levee, 6.5 feet below the crown. Corrugated metal cutoff wall. 1.5-inch conduit through the levee, 4 feet below the crown. Wooden walkway to a slant pump in a corrugated metal pump house on the berm. Gate valve on the berm. Hersey-Sparling meter on pipe at the waterside (WS) toe. Siphon breaker in a 24-inch corrugated metal pipe (CMP) riser on the landside (LS) shoulder. Pipe discharges into a 4-foot by 7-foot, inside dimensions, concrete distribution box at the LS toe. Meter pole at the LS toe. Field visit on 01/14/2014. (24-inch steel irrigation discharge pipe through the levee, slant pump, and all other appurtenances retained under Automatic Board Order (ABO) issued as Permit No. 10057, 1974 - David S. Lewis, care of Broomieside Farms). [Additional Reference(s): DWR Levee Log, 1990. USACE Sacramento O&M Manual 128, March 1960, (HLM 24.60)]. FS Date: 1/14/2014

WS view: slant pump on steel platform at levee berm. Walkway, exposed pipe, and gate valve on the berm.

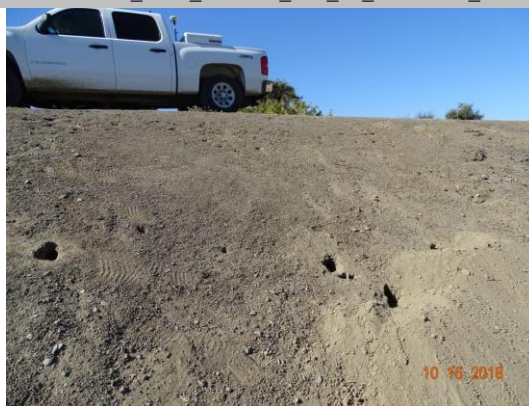
Photo 1 of 1 : SP\_2019\_RD1500\_189\_95\_20190304\_00044.jpg

LM Start	25.50	Rating **	M	Issue No.	95
LM End	25.50	Issue Type +	Ma	Location *	LS
Category	Earthen Levee			GPS Latitude/Longitude	
				Start	End
Item	Animal Control			38.952967 °	38.952967 °
				-121.837730 °	-121.837730 °
DWR ID	DWR_RD1500_01_f_2018_95				
Comment Code					
A3 : No rodents visible, but rodent burrows visible; need to backfill and compact or grout burrows.					
Inspector Comment					
There are rodent holes on the landside slope.

View of rodent holes on the landside slope. Fall 2018.

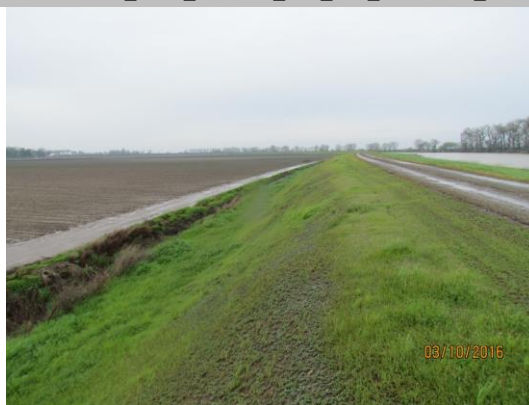
Photo 1 of 1 : SP\_2019\_RD1500\_189\_983\_20190304\_00085.jpg

LM Start	27.31	Rating **	M	Issue No.	983
LM End	27.44	Issue Type +	En	Location *	LS
Category	Earthen Levee			GPS Latitude/Longitude	
				Start	End
Item	Encroachments			38.972552 °	38.972924 °
				-121.825574 °	-121.823198 °
DWR ID	DWR_RD1500_01_s_2015_983				
Comment Code					
DT : Ditch					
Inspector Comment

View of the ditch on the landward side of the levee looking downstream.  
Spring 2016.

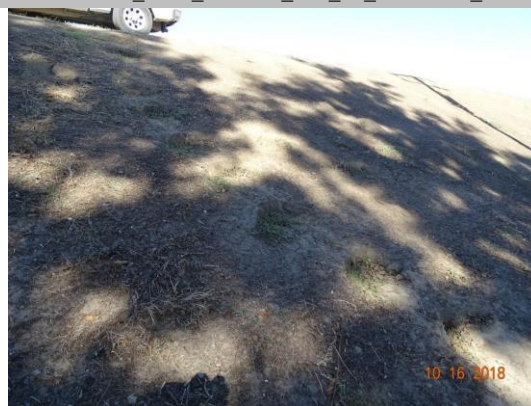
Photo 1 of 1 : SP\_2019\_RD1500\_189\_94\_20190304\_00043.jpg

LM Start	27.61	Rating **	M	Issue No.	94
LM End	27.61	Issue Type +	En	Location *	LS
Category	Earthen Levee			GPS Latitude/Longitude	
				Start	End
Item	Encroachments			38.974258 °	38.974258 °
				-121.820587 °	-121.820587 °
DWR ID	DWR_RD1500_01_f_2018_94				
Comment Code					
ST : Stairway					
Inspector Comment					
Stairs are dug into the landside slope.

View of stairs on the landside slope. Fall 2018.

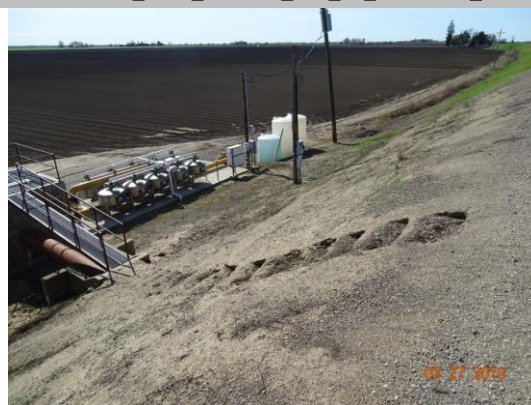
Photo 1 of 1 : SP\_2019\_RD1500\_189\_96\_20190304\_00045.jpg

LM Start	28.16	Rating **	M	Issue No.	96
LM End	28.16	Issue Type +	En	Location *	LS
Category	Earthen Levee			GPS Latitude/Longitude	
				Start	End
Item	Encroachments			38.982180 °	38.982180 °
				-121.819979 °	-121.819979 °
DWR ID	DWR_RD1500_01_s_2018_96				
Comment Code					
ST : Stairway					
Inspector Comment					
Steps are dug out on the landside levee slope.

View of steps on the landside slope. Spring 2018.

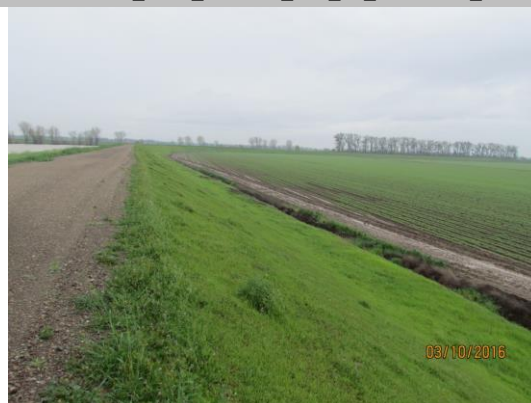
Photo 1 of 1 : SP\_2019\_RD1500\_189\_38\_20190304\_00020.jpg

LM Start	28.23	Rating **	M	Issue No.	38
LM End	29.23	Issue Type +	En	Location *	LS
Category	Earthen Levee			GPS Latitude/Longitude	
				Start	End
Item	Encroachments			38.983119 °	38.988538 °
				-121.819923 °	-121.806445 °
DWR ID	DWR_RD1500_01_s_2012_38				
Comment Code					
DT : Ditch					
Inspector Comment

View of the ditch on the landward side of the levee looking upstream. Spring 2016.

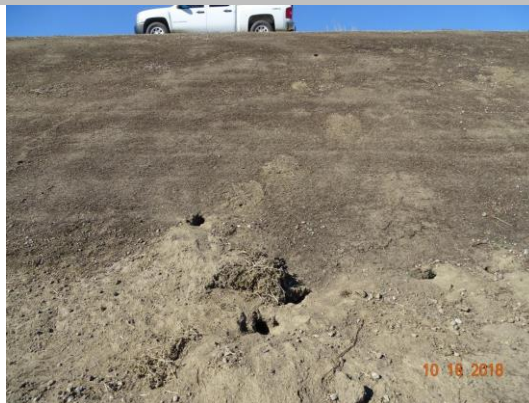
Photo 1 of 1 : SP\_2019\_RD1500\_189\_92\_20190304\_00042.jpg

LM Start	28.23	Rating **	M	Issue No.	92
LM End	28.23	Issue Type +	Ma	Location *	LS
Category	Earthen Levee			GPS Latitude/Longitude	
				Start	End
Item	Animal Control			38.983221 °	38.983221 °
				-121.819895 °	-121.819895 °
DWR ID	DWR_RD1500_01_f_2018_92				
Comment Code					
A3 : No rodents visible, but rodent burrows visible; need to backfill and compact or grout burrows.					
Inspector Comment					
Rodent holes are located at the landside toe.

View of rodent holes on the landside slope. Fall 2018.

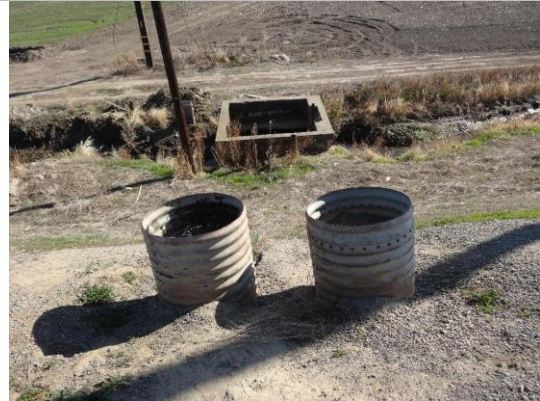
Photo 2 of 3 : UCIP\_SP\_2019\_50201\_52854.jpg

Item	DWR UCIP Field Study			38.993006 °	38.993006 °	
				-121.796025 °	-121.796025 °	
DWR ID	20084					
Comment Code						
Inspector Comment						
FS_ID:50201 DS_ID:20084 EP_NO: 10054 Repair Type: Non-Urgent Crossing Status: Found UCIP Comments: 08/29/2016: Found no evidence of leakage or subsidence. CMP risers are both silted in and need lids. Need a name change permit for new owner Brad Howalt. Possible sink hole in alignment with pipes on crown has been covered with concrete. Crossing has been downgraded from Urgent to Non-Urgent. (K. Fazel - UCIP)01/15/2014:Levee slope erosion due to leakage from siphon breaker.Water leaking from pipe near distribution box on landside levee toe.Overhead powerline. (P. Amatya - DWR) FIELD_STRUCT_DESC: 1 of 2: 20-inch steel irrigation discharge pipe through the levee, 5 feet below the crown. Corrugated metal cutoff wall Two siphon breakers in two 24-inch corrugated metal pipe (CMP) risers on the landside (LS) shoulder. Installed by USACE in 1952. Two slant pumps in a corrugated metal pump house mounted on a steel pile structure on the berm. 4-foot by 7-foot concrete inspection box for a Hersey-Sparling water meter on the berm in front of the pump house. Two flap gates in a 9.7-foot by 10.6-foot, outside dimensions, concrete distribution box at the LS toe. (20-inch steel irrigation discharge pipe through the levee, slant pumps, and all other appurtenances retained under Automatic Board Order (ABO) issued as Permit No. 10054, 1974 - William A. Larner). [Additional Reference(s): DWR Levee Log, 1993. USACE Sacramento O&M Manual 128, March 1960, (HLM 30.29), 18-inch pipe referenced]. FS Date: 8/29/2016

LS view: siphon breakers in CMP riser on levee slope and distribution box on levee toe.

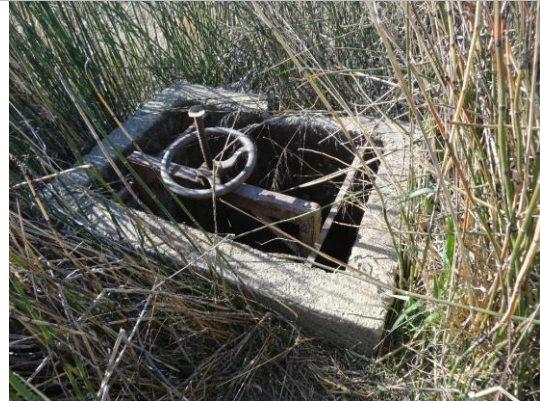
Photo 2 of 3 : UCIP\_SP\_2019\_50193\_51826.jpg

WS view: concrete surge box with slide gate on levee berm.

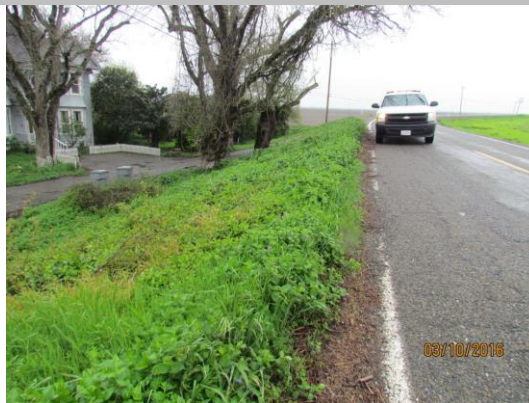
Photo 1 of 1 : SP\_2019\_RD1500\_189\_45\_20190304\_00022.jpg

LM Start	30.22	Rating **	M	Issue No.	45
LM End	30.22	Issue Type +	En	Location *	LS
Category	Earthen Levee			GPS Latitude/Longitude	
				Start	End
Item	Vegetation			38.997027 °	38.997027 °
				-121.794755 °	-121.794755 °
DWR ID	DWR_RD1500_01_s_2012_45				
Comment Code					
V6 : Landscaping					
Inspector Comment

View of the groundcover on the landward side of the levee looking downstream. Spring 2016.

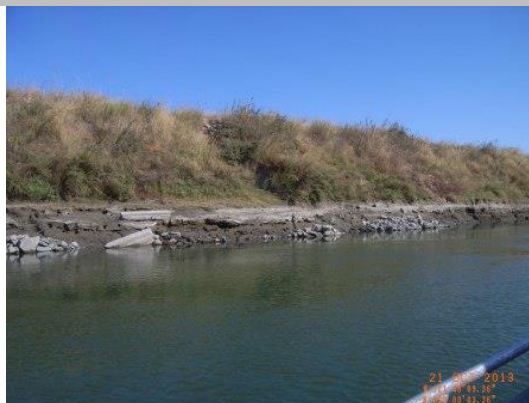
Photo 1 of 1 : SP\_2019\_RD1500\_189\_82\_20190304\_00033.jpg

LM Start	30.60	Rating **	A/W	Issue No.	82
LM End	30.75	Issue Type +	Ma	Location *	WS
Category	Supplemental			GPS Latitude/Longitude	
				Start	End
Item	2017 USACE Erosion Survey, DRAFT			38.999745 °	39.001413 °
				-121.800898 °	-121.802889 °
DWR ID	DWR_RD1500_01_f_2018_82				
Comment Code					
Inspector Comment					
2017 Site ID: SAC 116.0 L					
Status: Eroding					
2017 Field Notes: Minor new erosion throughout the site.					
Site History: 2000 - Eroding, vertical berm slope over a vertical cohesive toe; slow erosion but getting close to the toe. 2002 - Erosion is getting close to the levee, still eroding with some new small slumps.					
2004 - Some minor new erosion. 2006 - Some new erosion, cleaned off older scars and slump faces. 2008 - New, small, partial rotational failure. 2011 - Some new minor erosion. 2016 - Fresh erosion on lower bank.

USACE 2013 Photo #1

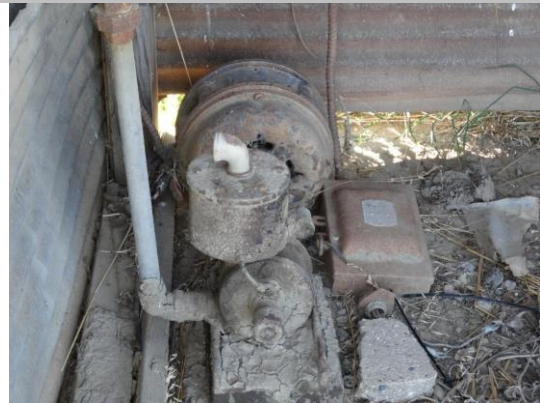
Photo 1 of 3 : UCIP\_SP\_2019\_28144\_51812.jpg

Comment Code						
Inspector Comment						
FS_ID:28144 DS_ID:20000 EP_NO: 15916 Repair Type: Non-Urgent Crossing Status: Found UCIP Comments: Surface erosion due to leaky pressure breaker on landside slope. FIELD_STRUCT_DESC: 18-inch steel irrigation discharge pipe through the levee, at an unknown depth. Waterside (WS) pump not mentioned in the Levee Log. Siphon breaker in a 24-inch corrugated metal pipe (CMP) riser on the landside (LS) slope. Pipe discharges into a 6-foot by 8-foot, inside dimensions, concrete distribution box at the LS toe. Installed by USACE in 1951. (12-inch steel irrigation discharge pipe through the levee and all other appurtenances retained under Automatic Board Order (ABO) issued as Permit No. 10034, 1974 - Leslie A. Butler. Replacement of the existing 12-inch discharge pipe with a new 18-inch discharge pipe through the levee authorized under Permit No. 15916, 1992 - Leslie A. Butler). [Additional Reference(s): DWR Levee Log, 1993. USACE Sacramento O&M Manual 128, March 1960, (HLM 31.26)]. FS Date: 1/15/2014

WS view: pump in CM pump house on levee shoulder. Looks abandoned.

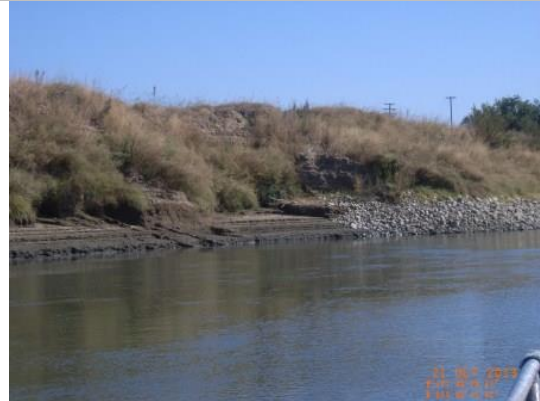
Photo 1 of 1 : SP\_2019\_RD1500\_189\_83\_20190304\_00034.jpg

Comment Code					
Inspector Comment					
2017 Site ID: SAC 116.5 L					
Status: Eroding					
2017 Field Notes: pipe and pump encroachment. site has been stable for a few years.					
Site History: 2003 - New sedimentation and some new small toe scallops at the upstream end; downstream end has some new erosion. 2004 - Some new erosion at the toe and upper bank and some small new rotational failures (mainly minor, except at the downstream end). 2007 - Some new slumps. 2009 - Some new scallops and site was extended upstream. 2010 - New deposition along upstream end of site, however there is also new erosion throughout the site. Site seems to be worsening, and eroding fast. Large habitat for bank swallows. 2011 - Some new minor erosion. 2012 - Minor new erosion. 2016 - Fresh erosion on lower bank.

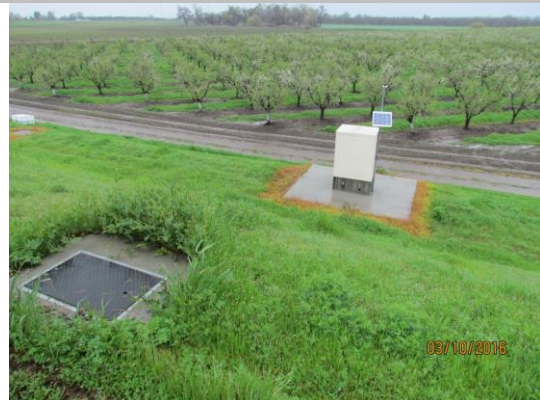
Photo 1 of 2 : SP\_2019\_RD1500\_189\_86\_20190304\_00038.jpg

LM Start	31.54	Rating **	A/W	Issue No.	86
LM End	31.54	Issue Type +	Ma	Location *	LS
Category	Earthen Levee			GPS Latitude/Longitude	
				Start	End
Item	Encroachments			39.006687 °	39.006687 °
				-121.814967 °	-121.814967 °
DWR ID	DWR_RD1500_01_s_2016_86				
Comment Code					
MW : Monitoring Well					
Inspector Comment					
UCIP installed this monitoring station for seepage in the area. Monitor for vandalism or damage PN: (18630).

View of the pizometer on the landward side of the levee. Spring 2016.

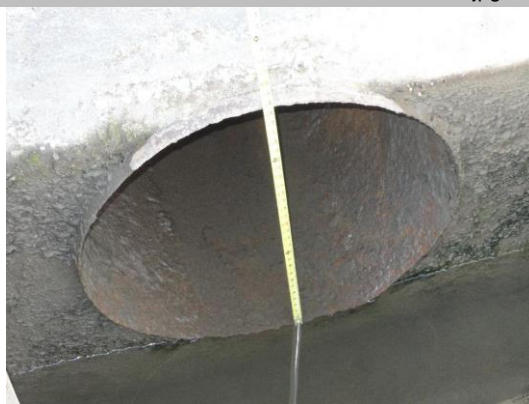
Photo 3 of 3 : UCIP\_SP\_2019\_28943\_53220.jpg

LS view: steel pipe in concrete distribution box on levee toe.

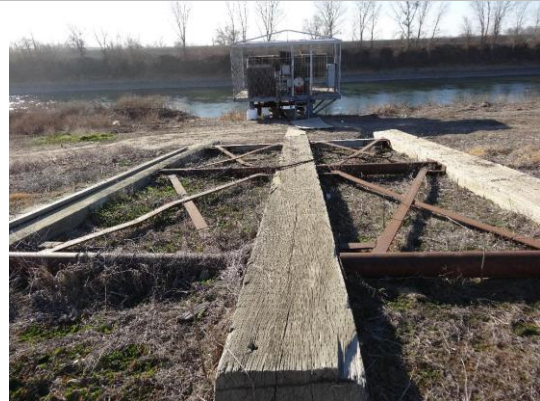
Photo 1 of 3 : UCIP\_SP\_2019\_28953\_53256.jpg

Comment Code						
Inspector Comment						
FS_ID:28953 DS_ID:20080 EP_NO: 5617 Repair Type: Non-Urgent Crossing Status: Found UCIP Comments: Not found- slide gate in 54 inch corrugated metal riser on waterside berm.Two 16-inch steel pipes (looks new). Leaky pipe near pump.Plant was working during field visit.Needs more info from LMA. There may be a new permit. FIELD_STRUCT_DESC: 1 of 2: 16-inch steel irrigation discharge pipe through the levee, at an unknown depth. Two slant pumps on a steel platform and under the shed. Two air vents on the waterside (WS) levee shoulder. Two pipes with gate valves discharge water into irrigation ditch on the landside (LS). Meter pole on landside toe. Previously only a 30-inch steel pipe through the levee and a slide gate in a corrugated metal pipe (CMP) riser on the WS. (Removal of existing structure in river, installation of an incline structure next to the levee with new slant pumps, connected to existing discharge pipe authorized under Permit Nos. 5617, 1967 - Adda Seamans, and 5617-A, 1968 - Oji Brothers Farm, Inc.). [Additional Reference(s): DWR Levee Log, 2005. USACE Sacramento O&M Manual 128, March 1960, (HLM 33.56), 36-inch pipe referenced]. FS Date: 1/15/2014

WS view: slant pumps on steel platform in shed on berm.

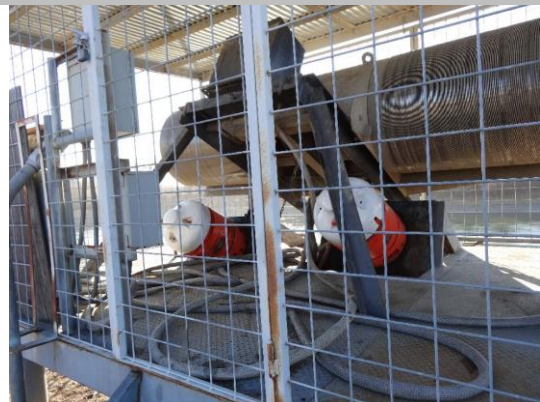
Photo 2 of 3 : UCIP\_SP\_2019\_28953\_53255.jpg

WS view: closer view of slant pumps on steel platform in shed on berm.

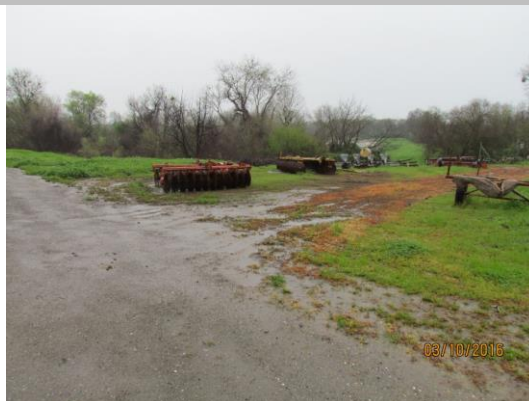
Photo 1 of 1 : SP\_2019\_RD1500\_190\_12\_20190304\_00005.jpg

LM Start	0.00	Rating **	M	Issue No.	12
LM End	0.00	Issue Type +	En	Location *	WS
Category	Earthen Levee			GPS Latitude/Longitude	
				Start	End
Item	Encroachments			38.761121 °	38.761121 °
				-121.674592 °	-121.674592 °
DWR ID	DWR_RD1500_02_s _ 2012_12				
Comment Code					
EQ : Equipment					
Inspector Comment

View of the equipment on the levee crown looking upstream. Spring 2016.

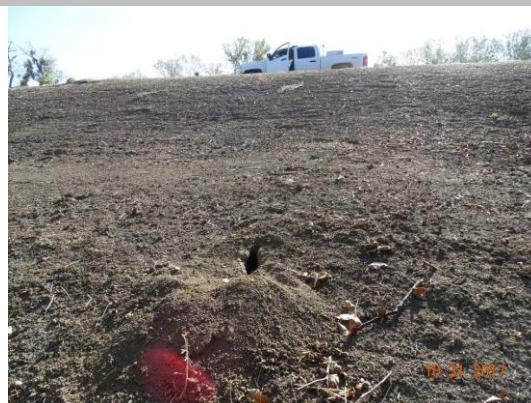
Photo 1 of 1 : SP\_2019\_RD1500\_190\_39\_20190304\_00011.jpg

LM Start	0.13	Rating **	M	Issue No.	39
LM End	0.13	Issue Type +	Ma	Location *	LS
Category	Earthen Levee			GPS Latitude/Longitude	
				Start	End
Item	Animal Control			38.762429 °	38.762429 °
				-121.672924 °	-121.672924 °
DWR ID	DWR_RD1500_02_f_2017_39				
Comment Code					
A3 : No rodents visible, but rodent burrows visible; need to backfill and compact or grout burrows.					
Inspector Comment					
There is a rodent hole near the landside toe.

View of rodent hole on landside slope. Fall 2017.

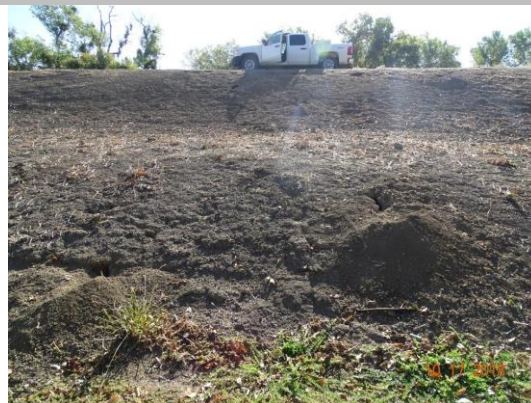
Photo 1 of 1 : SP\_2019\_RD1500\_190\_16\_20190304\_00009.jpg

LM Start	0.14	Rating **	M	Issue No.	16
LM End	0.14	Issue Type +	Ma	Location *	LS
Category	Earthen Levee			GPS Latitude/Longitude	
				Start	End
Item	Animal Control			38.762564 °	38.762564 °
				-121.672771 °	-121.672771 °
DWR ID	DWR_RD1500_02_f_2018_16				
Comment Code					
A3 : No rodents visible, but rodent burrows visible; need to backfill and compact or grout burrows.					
Inspector Comment					
There are multiple holes on the landside slope.

View of rodent holes on the landside slope. Fall 2018.

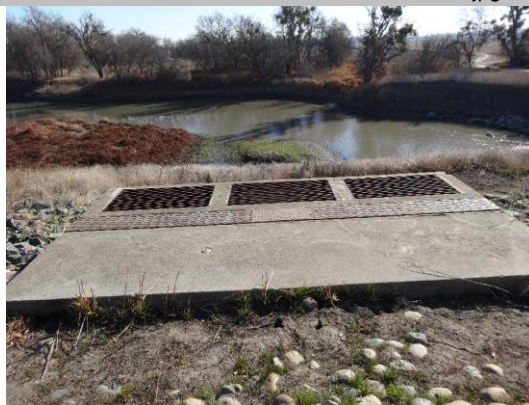
Photo 2 of 3 : UCIP\_SP\_2019\_28955\_53263.jpg

WS view: concrete surge structure on waterside shoulder.

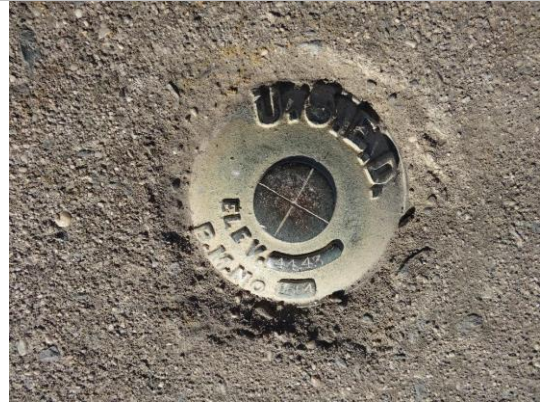
Photo 3 of 3 : UCIP\_SP\_2019\_28956\_53267.jpg

Comment Code						
Inspector Comment						
FS_ID:28956 DS_ID:20026 EP_NO: 10088 Repair Type: No Action Needed Crossing Status: Found UCIP Comments: USED Bench Mark on concrete structure at waterside shoulder. FIELD_STRUCT_DESC: [Reclamation District No. 1500, Pumping Plant No. 2] 3 of 3: 48-inch by 48-inch reinforced concrete box drainage discharge conduit under the levee, 37 feet below the crown. Two concrete cutoff walls. Pumps in concrete pumping plant on the landside (LS). Slide gates mounted on a concrete structure on the waterside (WS) slope. Discharges in borrow pit. Flap gates on the WS end. (48-inch by 48-inch reinforced concrete box drainage discharge conduit under the levee and all other appurtenances retained under Automatic Board Order (ABO) issued as Permit No. 10088, 1974 - Reclamation District No. 1500). [Additional Reference(s): DWR Levee Log, 1993. USACE Sacramento O&M Manual 129, June 1954, (Station 1226+00)]. FS Date: 1/21/2014

WS view: USED Bench Mark on concrete structure at levee shoulder.

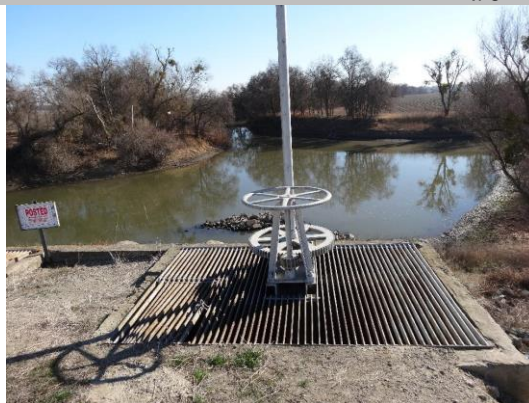
Photo 1 of 3 : UCIP\_SP\_2019\_28891\_53137.jpg

Comment Code					
Inspector Comment					
FS_ID:28891 DS_ID:20088 EP_NO: 10088 Repair Type: No Action Needed Crossing Status: Found UCIP Comments: Pumping plant was working during the field visit. Three 8.5 ft. X 8.5 ft. concrete box on waterside shoulder. FIELD_STRUCT_DESC: [Reclamation District No. 1500, Pumping Plant No. 1] 1 of 3: 84-inch by 84-inch reinforced concrete box drainage discharge conduit under the levee, 24 feet below the crown. Pumps in concrete pumping plant on the landside (LS). Slide gates mounted on a concrete structure on the waterside (WS) slope. Discharges in a concrete spillway and the borrow pit. Ramp on the WS slope. (84-inch by 84-inch reinforced concrete box drainage discharge conduit under the levee and all other appurtenances retained under Automatic Board Order (ABO) issued as Permit No. 10088, 1974 - Reclamation District No. 1500). [Additional Reference(s): DWR Levee Log, 2005. USACE Sacramento O&M Manual 129, June 1954, (Station 1224+75), three 78-inch concrete conduits referenced]. FS Date: 1/21/2014

WS view: slide gate in concrete box on levee shoulder.

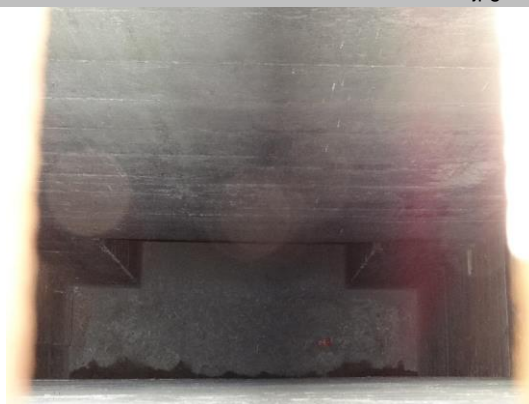
Photo 2 of 3 : UCIP\_SP\_2019\_28891\_53136.jpg

WS view: inside view of concrete box on levee shoulder.

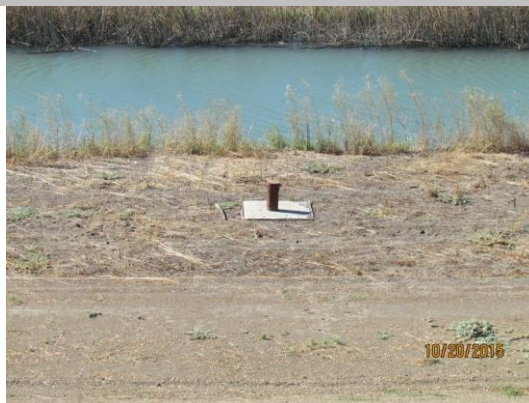
Photo 3 of 3 : SP\_2019\_RD1500\_190\_4\_20190304\_00003.jpg

LM Start	<b>14.13</b>	Rating **	U	Issue No.	<b>4 (cont)</b>
LM End	<b>14.13</b>	Issue Type +	Ma	Location *	LS

View of the relief well at historical boil 12. Fall 2015.

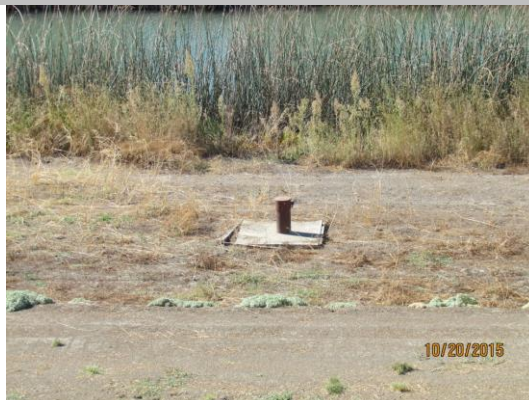
Photo 1 of 1 : SP\_2019\_RD1500\_190\_11\_20190304\_00004.jpg

LM Start	14.47	Rating **	A/W	Issue No.	11
LM End	14.47	Issue Type +	Ma	Location *	LS
Category	Earthen Levee			GPS Latitude/Longitude	
				Start	End
Item	Underseepage Relief Wells			38.951413 °	38.951413 °
				-121.673856 °	-121.673856 °
DWR ID	DWR_RD1500_02_s_2012_11				
Comment Code					
Inspector Comment

A relief well at historical boil 16. Fall 2015.

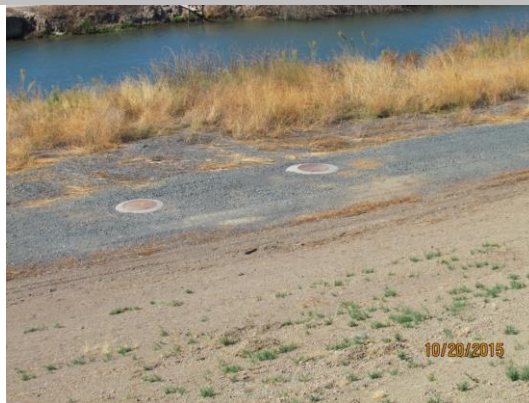
Photo 1 of 2 : SP\_2019\_RD1500\_190\_13\_20190304\_00006.jpg

LM Start	18.17	Rating **	A/W	Issue No.	13
LM End	18.17	Issue Type +	Ma	Location *	LS
Category	Earthen Levee			GPS Latitude/Longitude	
				Start	End
Item	Underseepage Relief Wells			38.987031 °	38.987031 °
				-121.725049 °	-121.725049 °
DWR ID	DWR_RD1500_02_s_2012_13				
Comment Code					
Inspector Comment

View of two of four drains on the landward side of the levee. Fall 2015.

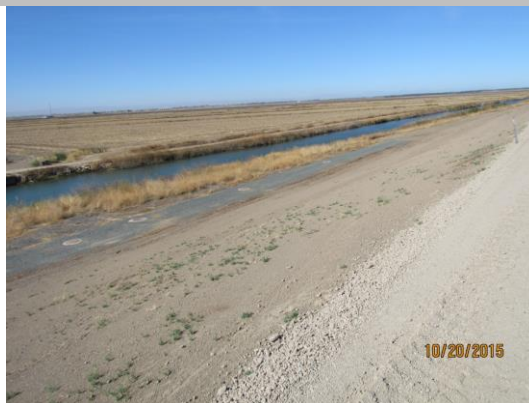
Photo 2 of 2 : SP\_2019\_RD1500\_190\_13\_20190304\_00007.jpg

View of the 4 drains at the levee toe on the landward side. Fall 2015.

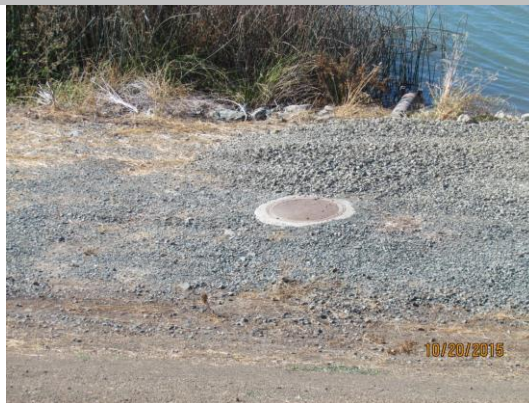
Photo 1 of 1 : SP\_2019\_RD1500\_190\_15\_20190304\_00008.jpg

LM Start	18.43	Rating **	A/W	Issue No.	15
LM End	18.43	Issue Type +	Ma	Location *	LS
Category	Earthen Levee			GPS Latitude/Longitude	
				Start	End
Item	Underseepage Relief Wells			38.989962 °	38.989962 °
				-121.727896 °	-121.727896 °
DWR ID	DWR_RD1500_02_s_2015_15				
Comment Code					
Inspector Comment

View of the toe drainage at the landward toe berm. Fall 2015.
